# **ENGINE MECHANICAL**

### **MODIFICATION NOTICE:**

$\bullet\,$  TD42T engine has been added. For specifications other than those described here, refer to the TD42 engine.

TD42T

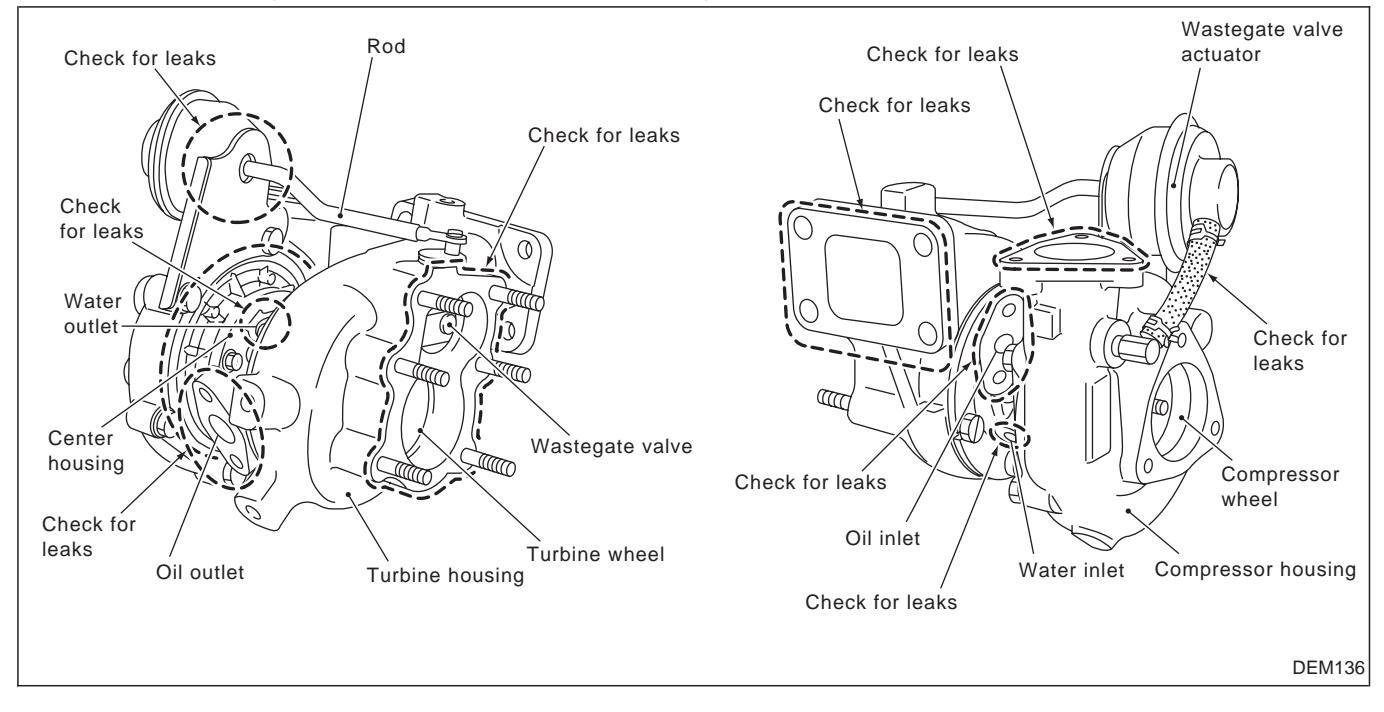
#### Perform the following checks. If NG, replace turbocharger unit.

#### **OIL AND WATER TUBES**

Check tubes for clogging.

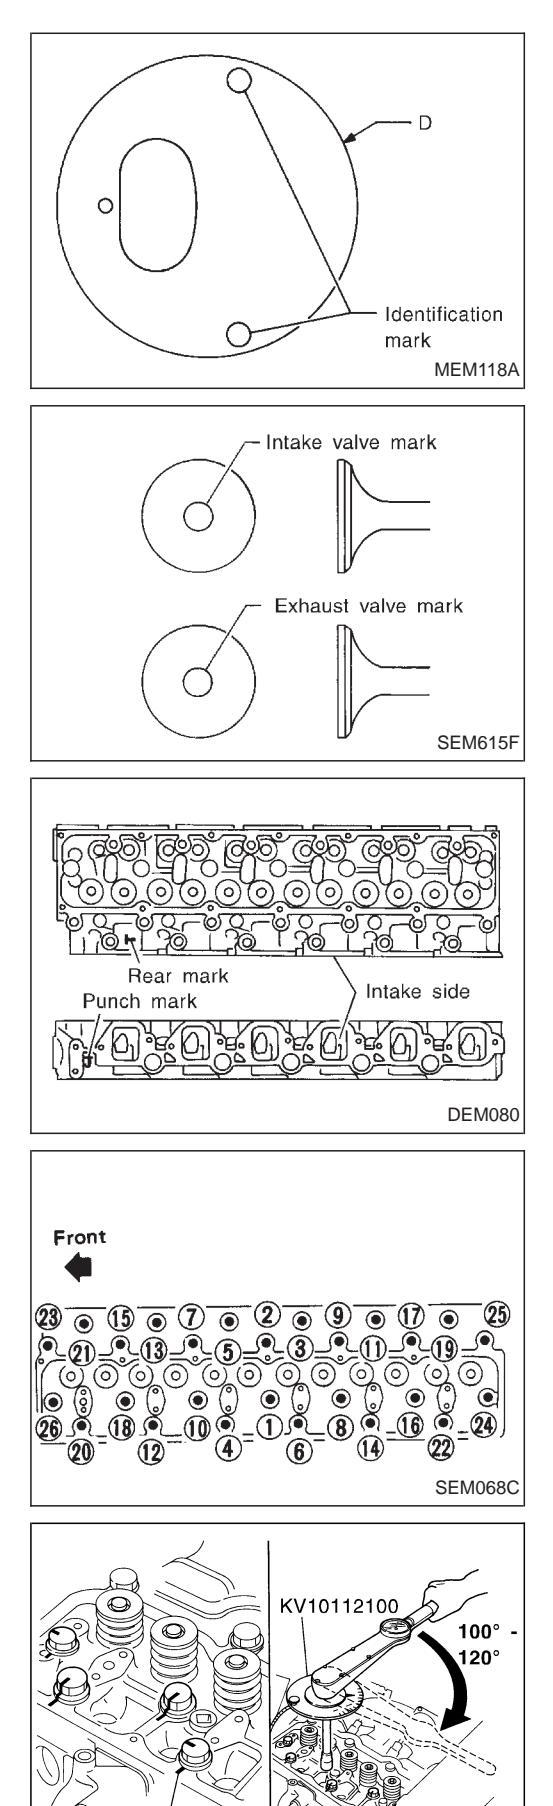
Paint mark

### Cylinder head bolt tightening procedure

Apply oil to the thread portion and seat surface of bolts and tighten cylinder head bolts using Tool.

1st: Tighten bolts to 39 - 44 N⋅m (4.0 - 4.5 kg-m, 29 - 33 ft-lb). 2nd: Tighten bolts to 59 - 64 N⋅m (6.0 - 6.5 kg-m, 43 - 47 ft-lb).

- (1) Mark exhaust side of cylinder head and cylinder head bolts with paint as shown.
- (2) Turn all bolts 110±10 degrees clockwise.
- (3) Check that the paint mark of each bolt is facing the front of the vehicle.
- Always check the bolt tightening angle with an angle wrench or protractor. Do not check visually.

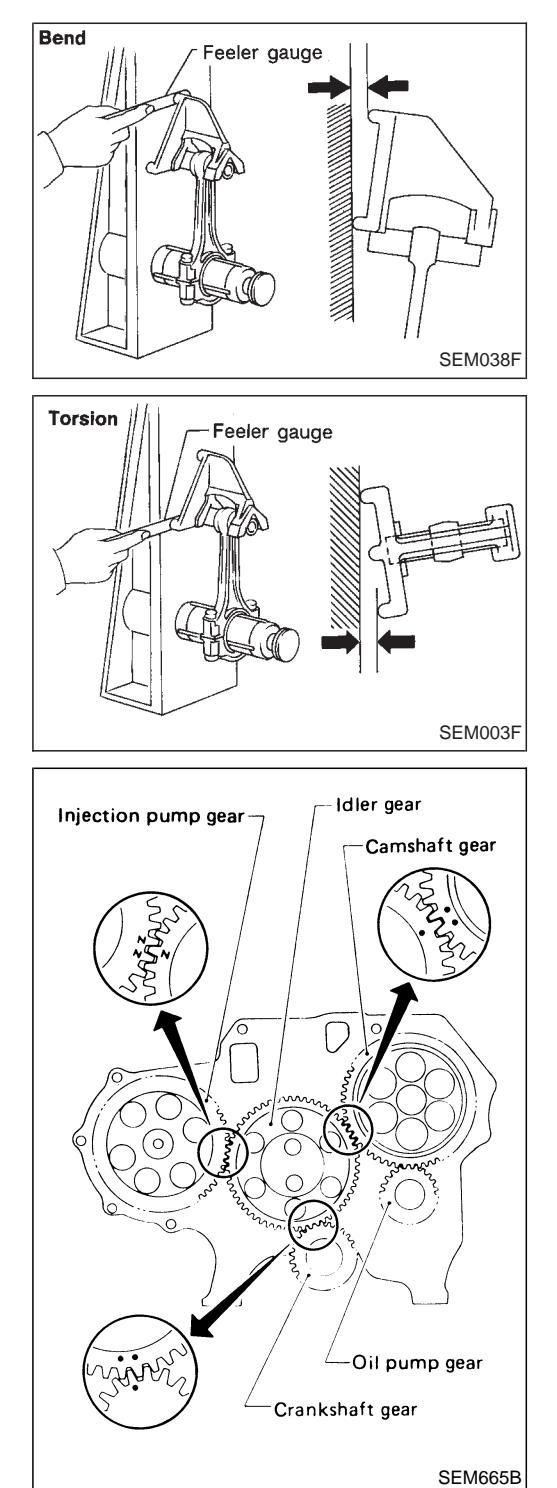
### Inspection and Replacement (Cont'd) CONNECTING ROD BEND AND TORSION

Bend and torsion: mm (in) Limit

0.05 (0.0020) per 100 (3.94) length
